**When
Coating
Asphalt,
Life Can**

**Be Trial by Fire: The Best
Dam Job
in Durango**

PROJECT:
Terminal Dam on Electra Lake
North of Durango, Colorado

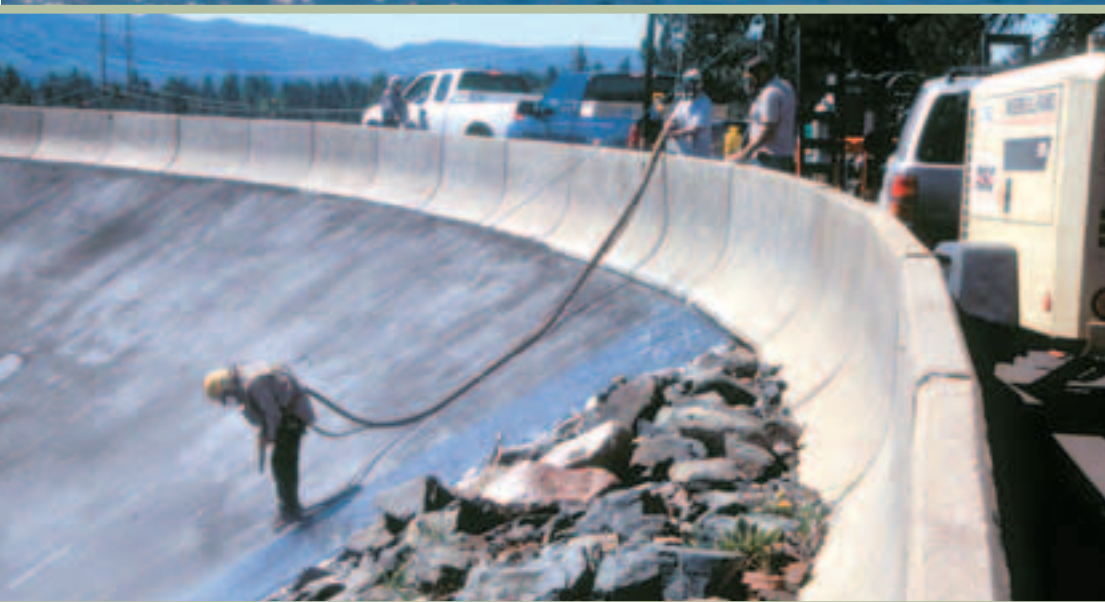
With ventilated hood and safety harness (*above*) this TRS crew member is well-suited to sandblast the slippery, 45-degree slope. Dropping some 40 feet to shimmering Electra Lake (*background*) Terminal Dam is nearly completely waterproofed with an ebony coating of CIM.

"The dam was constructed with asphalt, which caused a lot of problems," said Snow. "Asphalt absorbs heat. When you put on the coating, moisture gets trapped inside the asphalt." The dam's entire surface would have to be sandblasted, and the remaining loose spots of asphalt ground to a smooth finish using a hand-held wire wheel grinder.

"That was a chore in itself," Snow added. "Trying to hold up a sandblasting hose on a 45-degree incline isn't easy to do. As you blow the sand, it gets under your feet and makes you slip and slide." To keep workers from falling into the lake, TRS applied a hoist attachment to the person operating the sandblaster, who wore a full-body safety harness. Because of the close attention paid to safety precautions, said Snow, no one ended up taking an unplanned swim.

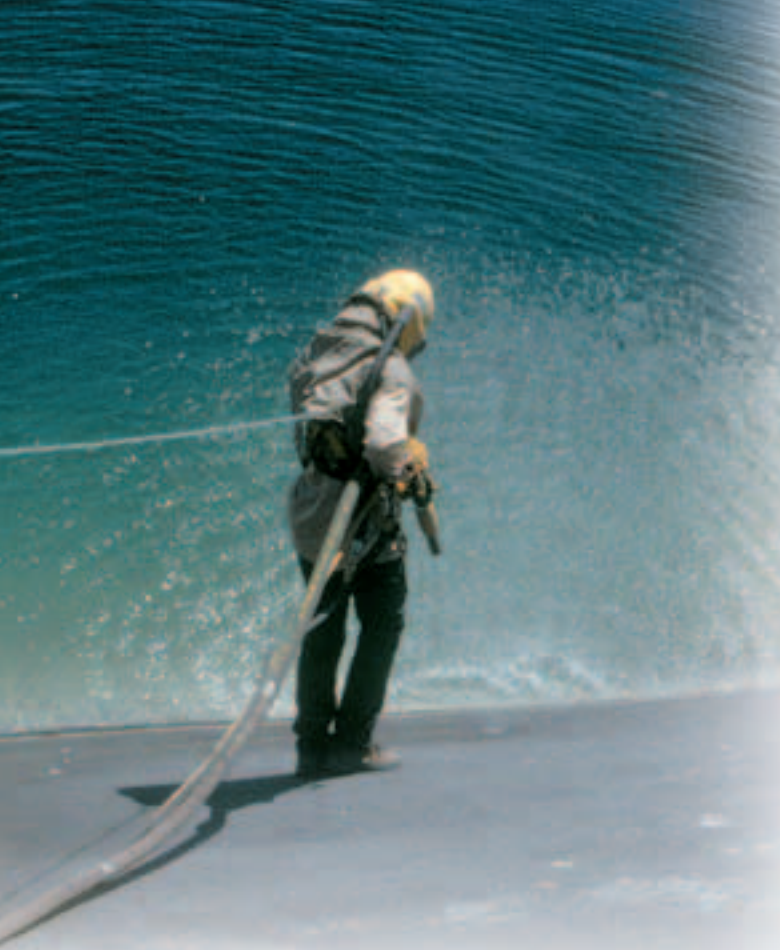
Holding a sandblasting hose while perched on an incline is a balancing act, but safety precautions prevented any unplanned swims throughout the job.
